Monitoring Cruise at the Morris Cove Borrow Pit

# Disposal Area Monitoring System DAMOS

Contribution 129  
June 2001

**MONITORING CRUISE  
AT THE MORRIS COVE  
BORROW PIT**

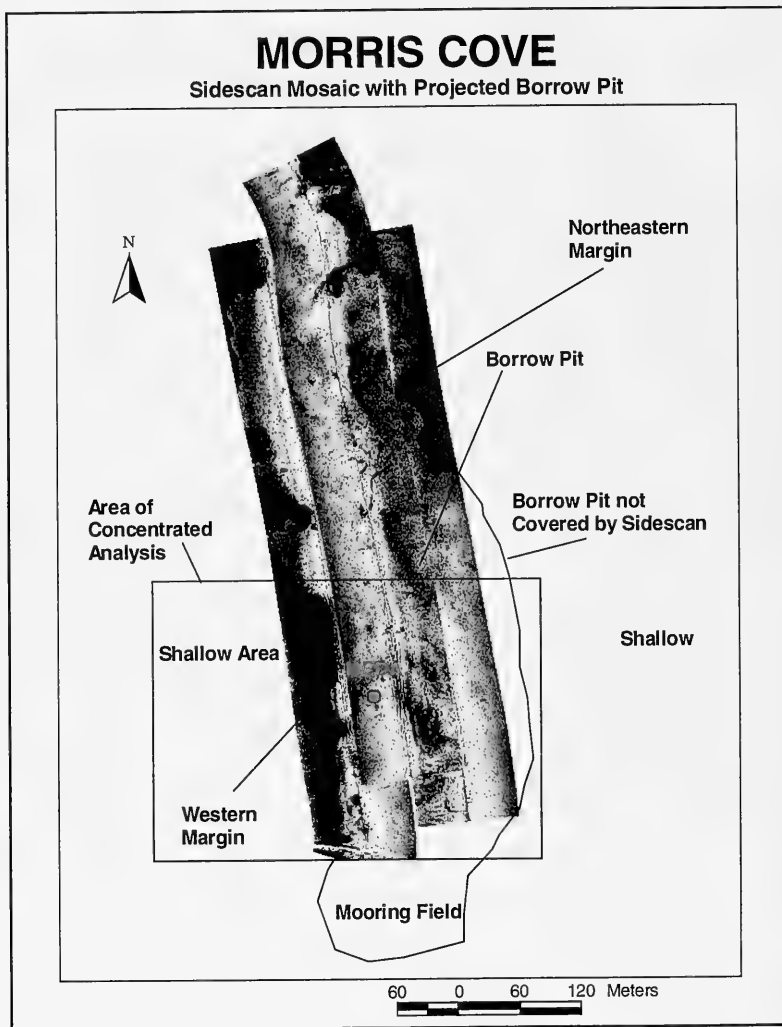
The side-scan sonar data showed a clear differentiation between softer sediments within the borrow pit and coarser, more compact sediments comprising the outer walls of the pit. Multiple bottom features with increased vertical relief and surface roughness detected within a 50 m radius of the central disposal point and to the east of this point were attributed to dredged material deposition. Both the side-scan sonar and towed video data suggested that the impacts associated with the deposition of dredged material were contained largely within the southern portion of the Morris Cove borrow pit. The controlled placement of small barge loads of dredged material had facilitated the creation of a small-scale sediment deposit within the confines of the pit.

**Figure 3-1.** Side-scan sonar mosaic of the three lanes occupied over the Morris Cove borrow pit

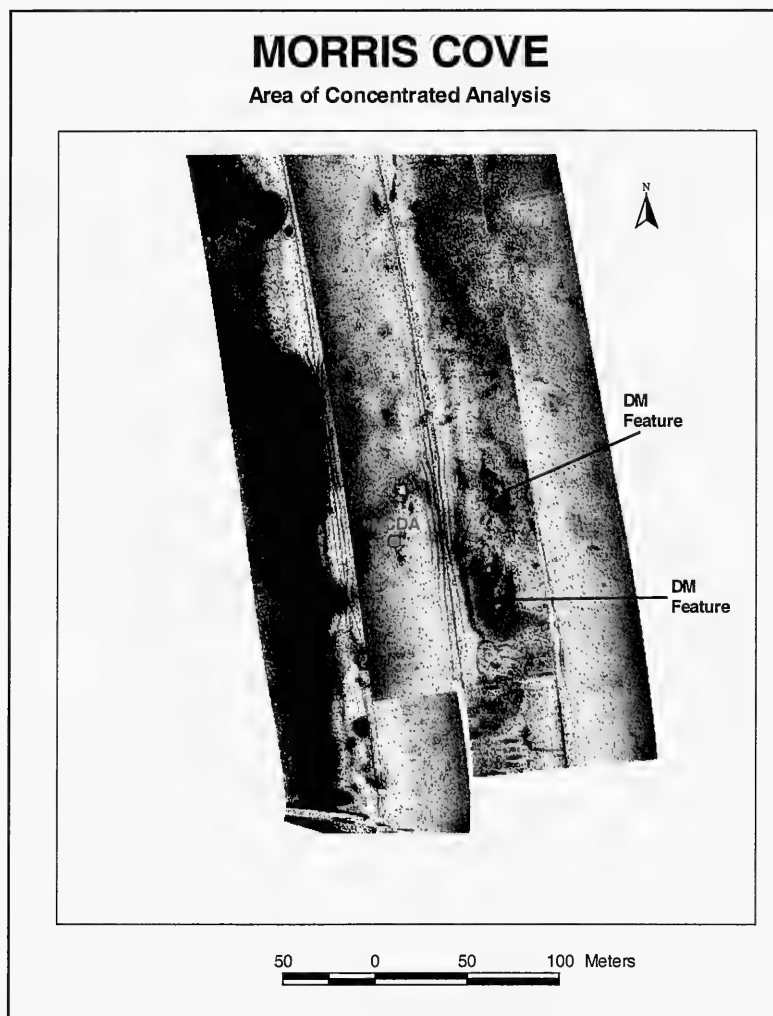
**Figure 3-2.** Side-scan sonar image displaying several acoustically detectable bottom features within the Morris Cove borrow pit in close proximity to the MCDA buoy position

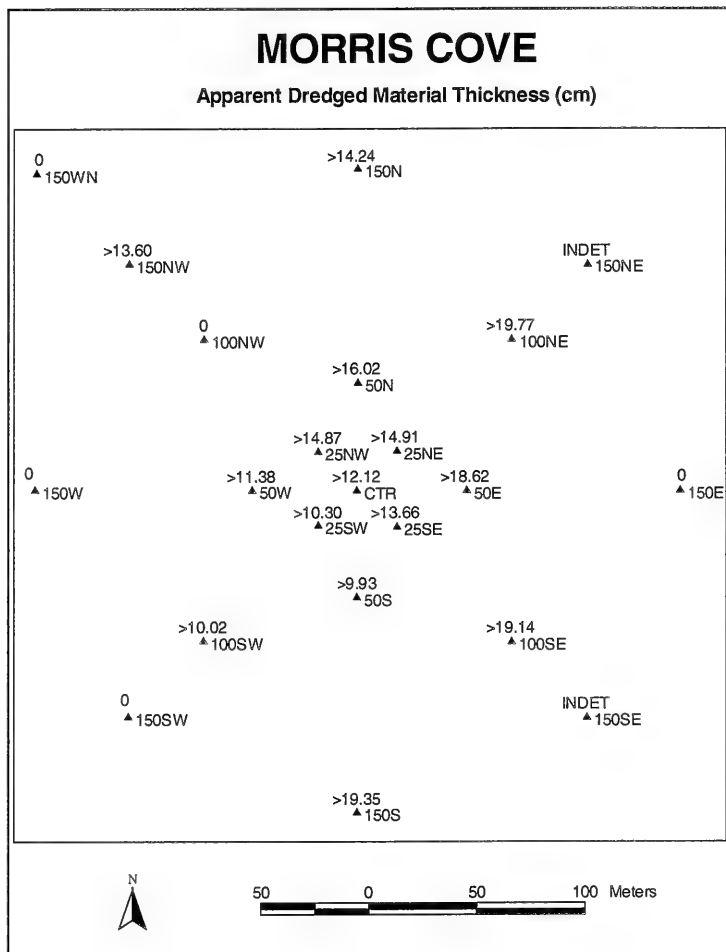
Dredged material was detected in the REMOTS® images at 15 of 22 borrow pit stations (Table 3-1; Figure 3-3). The dredged material layer extended from the sediment surface to below the imaging depth of the REMOTS® camera at all of these stations (i.e., dredged material greater than penetration, denoted by a “greater than” sign in Table 3-1 and Figure 3-3). Surface sediments considered to be ambient bottom (i.e., unaffected by dredged material disposal) were observed in the replicate images at Stations 100NW, 150E, 150SW, 150W, and 150WN located outside or on the presumed edges of the pit (Table 3-1; Figure 3-3). At Stations 150NE and 150SE, it could not be clearly determined from the images whether the material present was dredged material or ambient sediment (INDET = indeterminate in Table 3-1 and Figure 3-3).

**Figure 3-3.** Map showing the average thickness of the dredged material layer observed in replicate sediment profile images at each station. A “greater than” sign indicates that the dredged material layer extended below the imaging depth of the sediment profile camera.

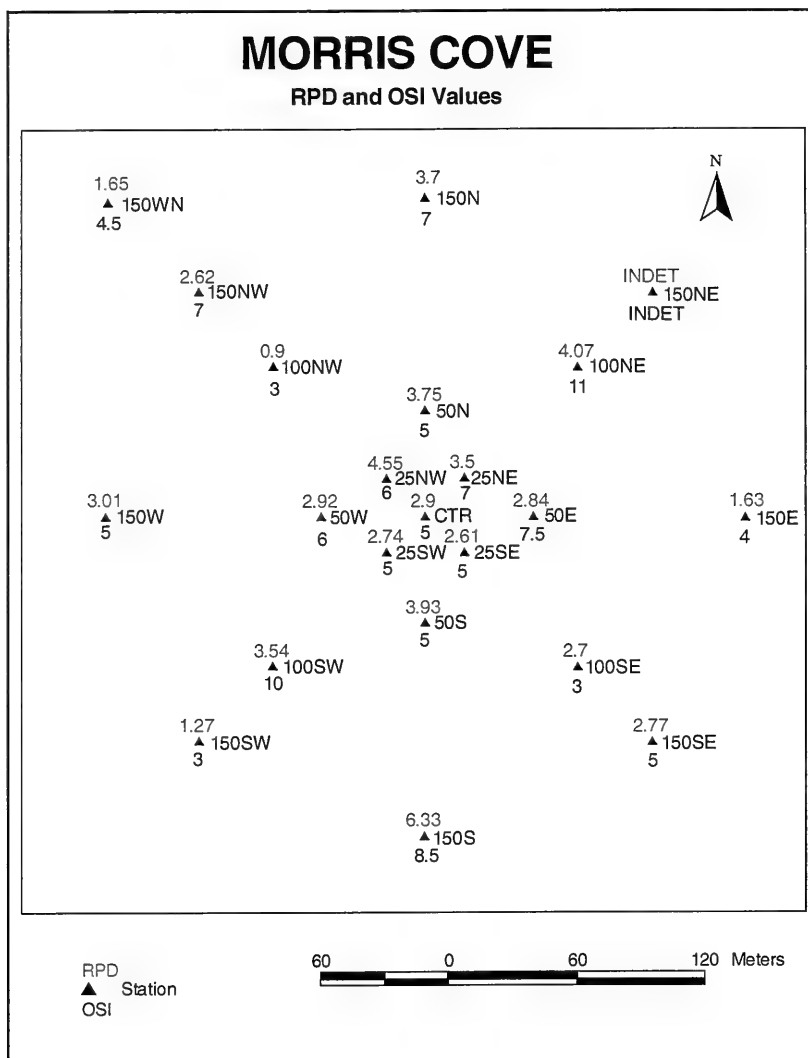
**Figure 3-6.** Map showing average RPD and OSI values at each borrow pit station.

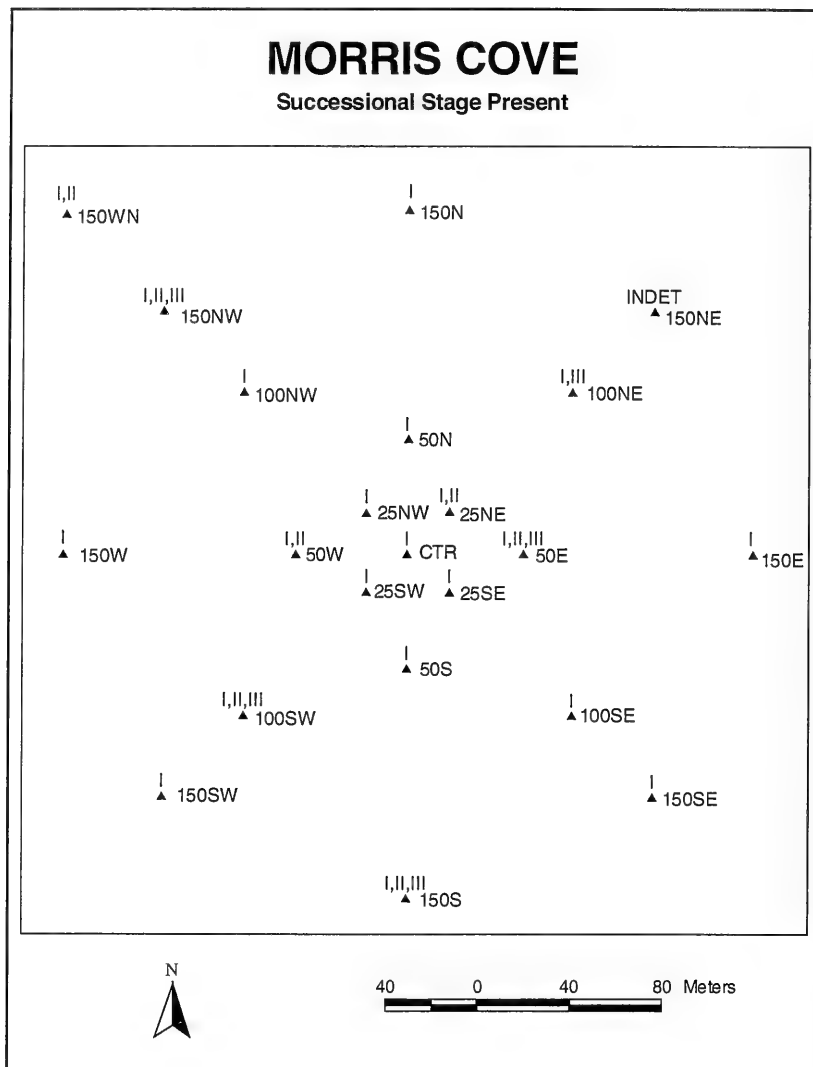
**Figure 3-7.** Map showing infaunal successional stages present at each borrow pit station.

**Figure 3-8.** REMOTS® image showing small, tubicolous, opportunistic polychaetes (Stage I) present at the surface of fine-grained dredged material at station 100SW within the borrow pit.

polychaetes present at the sediment surface (Figures 3-7 and 3-8; Table 3-1). Tube-dwelling amphipods (*Ampelisca* sp), representative of Stage II, were observed at 7 of the 22 stations (Figures 3-7 and 3-9). Stage III activity, evidenced by active feeding voids produced by head-down, deposit-feeding infauna, was predominately noted in the subsurface at Stations 100NE, 100SW, 150NW, 150S, and 50E (Figures 3-7 and 3-9). Overall, the presence of a diverse mixture of Stages I, II and III organisms at the stations within the borrow pit indicate that benthic recolonization of this area was occurring as expected at the time of the September 2000 survey.

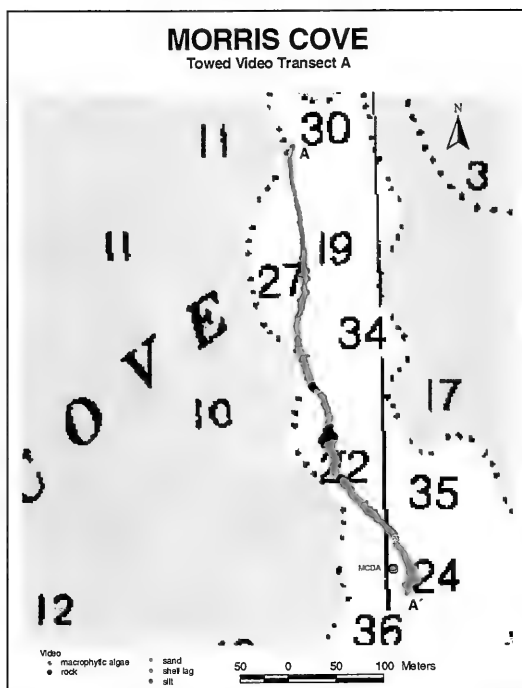
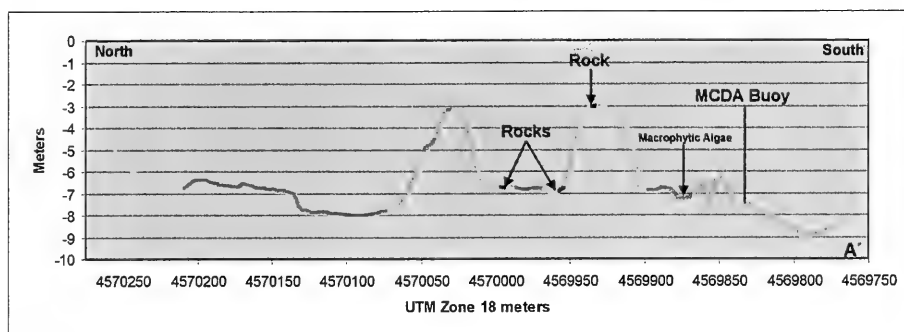
Transect A was a longitudinal pass within the boundaries of the borrow pit, concentrating on the western margin of the bottom feature (Figure 3-10). The starting point for this line was placed approximately 450 m north of the MCDA buoy position. Soft material was observed for the majority of this transect with silty sand and shell fragments observed as the video sled encountered the sloping walls of the pit. Silt was predominant in areas of low relief and tended to be found at water depths below 5 m. A few patches of pebble and cobble sized rock were also observed on the bottom, as the video sled was towed south and east through the pit. The seafloor within a 30 m radius of the MCDA buoy position was characterized as a silty sand, but showed no obvious differences from the surface sediments in the northern portion of the borrow pit.

**Figure 3-10.** Aerial perspective and profile view of surface sediment characterization data obtained for Transect A displaying distribution of fine sand (yellow), silt (magenta), shell lag (tan), rock (black) and macrophytic algae (gray).

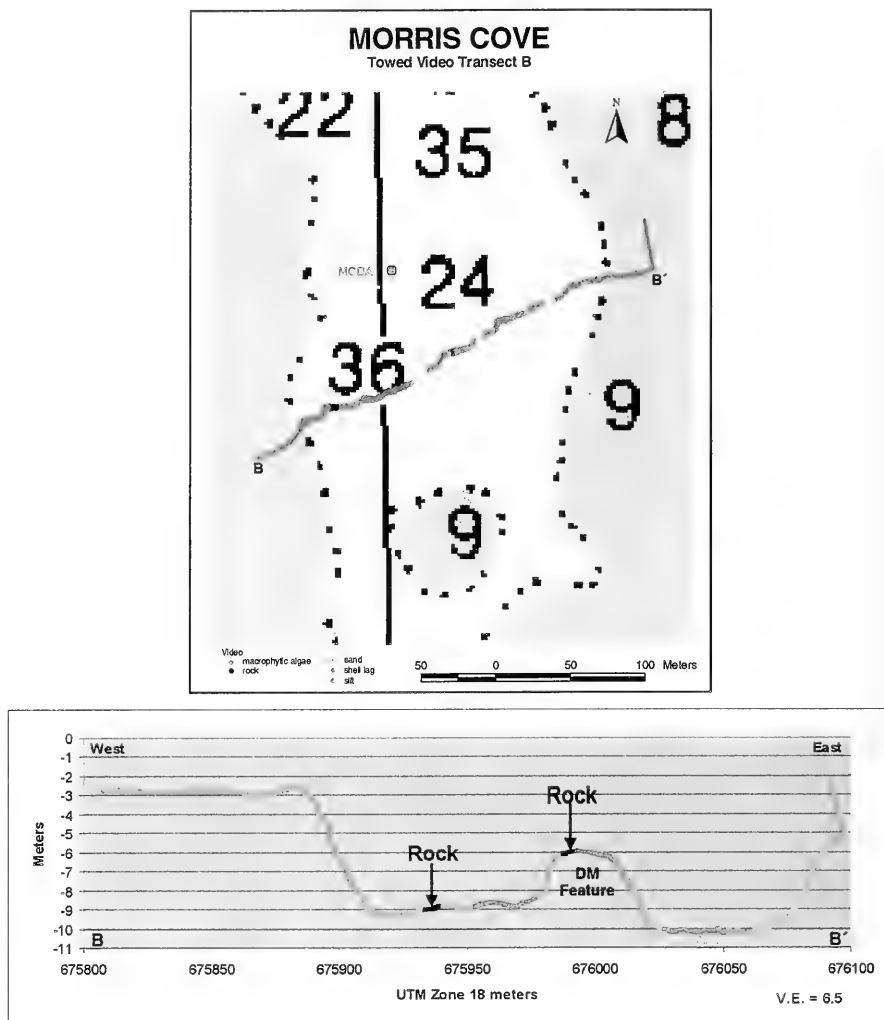
Transect B represents the first transverse route occupied over the Morris Cove borrow pit. The video sled passed approximately 60 m southeast of the disposal buoy position (Figure 3-11). Fine, silty sand was observed in the shallow areas on either end of the transect, and patches of silt were found at depth. Once again, a correlation with bottom slope was detected as the margins of the pit were composed of fine sand or fine sand with shell.

**Figure 3-11.** Aerial perspective and profile view of surface sediment characterization data obtained for Transect B displaying distribution of fine sand (yellow), silt (magenta), shell lag (tan), rock (black) and macrophytic algae (gray).

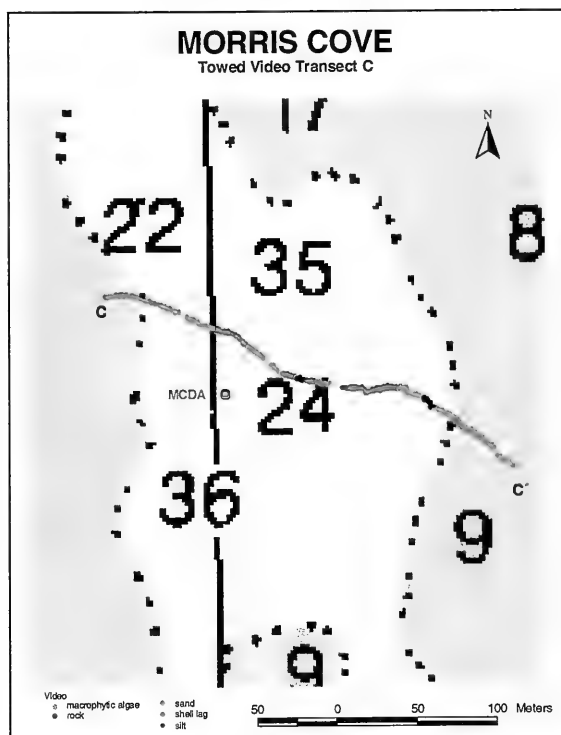
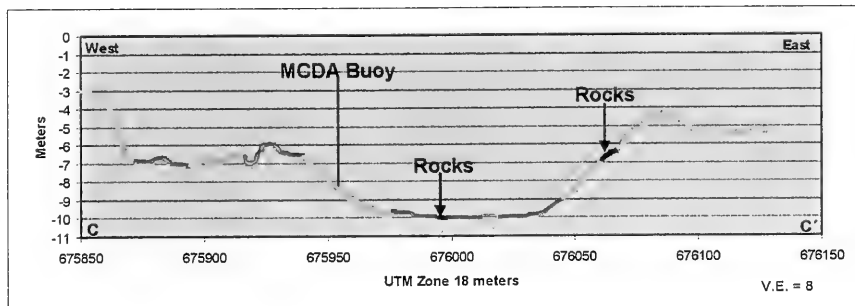
**Figure 3-12.** Aerial perspective and profile view of surface sediment characterization data obtained for Transect C displaying distribution of fine sand (yellow), silt (magenta), shell lag (tan), rock (black) and macrophytic algae (gray).

Transect C also represents a transverse pass over the borrow pit. Once again, small patches of silt, fine silty sand, fine sand with shell, and a limited amount of pebble and cobble sized rocks were observed within the video record (Figure 3-12). The video sled passed 20 m northeast of the disposal buoy position as it was towed east-southeast across the borrow pit. Similar to the interpretations of Transect A, the surface sediments in close proximity to the MCDA buoy position were characterized as fine, silty sand. No obvious visual distinctions were observed between ambient sediment and the surface of the recent dredged material deposit. The depth profile for Transect C showed limited vertical relief to the west of the buoy position before the bottom gradually sloped to the deepest portion of the pit (water depth of 10 m). Silt was the major constituent of the sediments within the deepest portion of the pit.

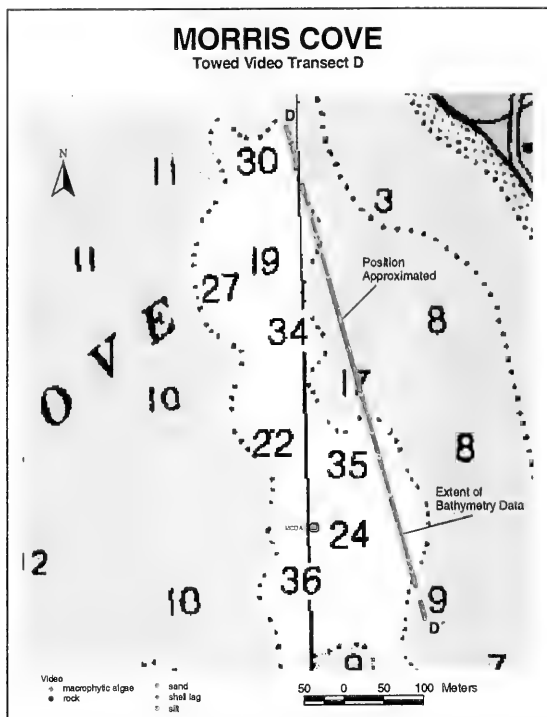
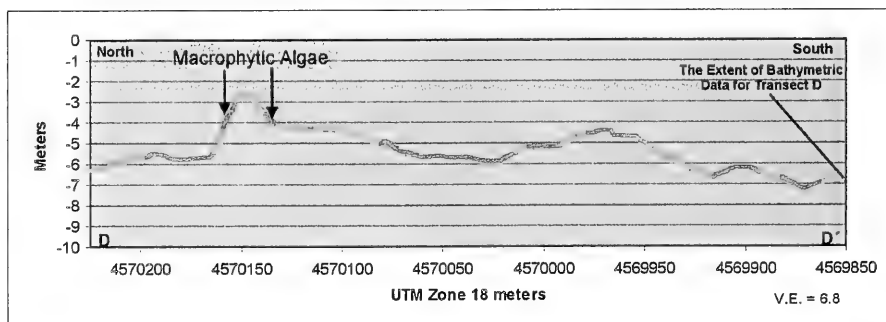
**Figure 3-13.** Aerial perspective and profile view of surface sediment characterization data obtained for Transect D displaying distribution of fine sand (yellow), silt (magenta), shell lag (tan), rock (black) and macrophytic algae (gray).

Transect D was the second longitudinal pass made over the Morris Cove borrow pit, and designed to document the composition of sediment along the eastern margin of the pit. Due to unreliable navigation data from the DGPS unit during the occupation of Transect D, the position of the video sled was approximated for the majority of this line. The bathymetric data were used in conjunction with the NOAA chart pictured in Figure 3-13 to place the line along the eastern margin of the borrow pit. Overall, a similar lithology and distribution of sediments were observed, relative to other transects. Fine sand with varying shell content was noted in areas near the walls of the pit and silt was found over the flat areas within the pit. The video data collected in the southern portion of the borrow pit suggested that seafloor composition east of the buoy position is quite patchy.

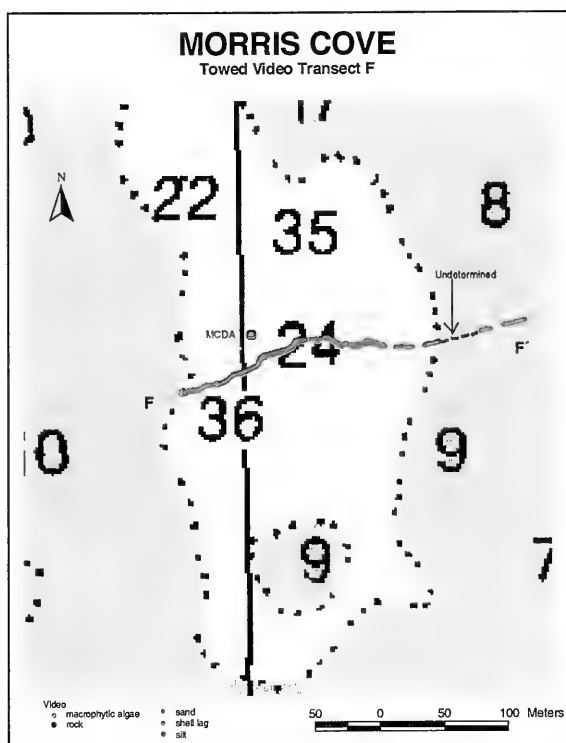
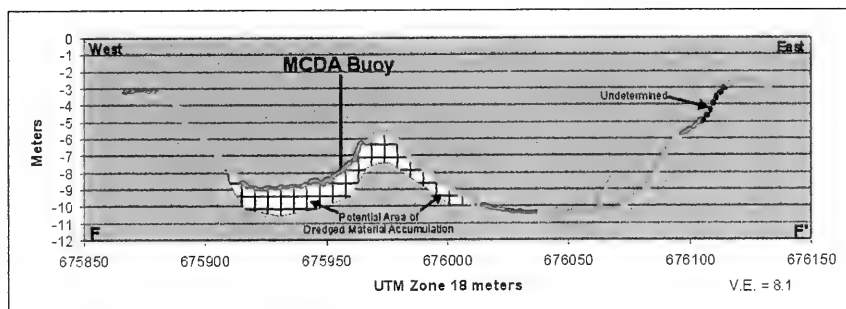
**Figure 3-14.** Aerial perspective and profile view of surface sediment characterization data obtained for Transect F displaying distribution of fine sand (yellow), silt (magenta), shell lag (tan), and macrophytic algae (gray).

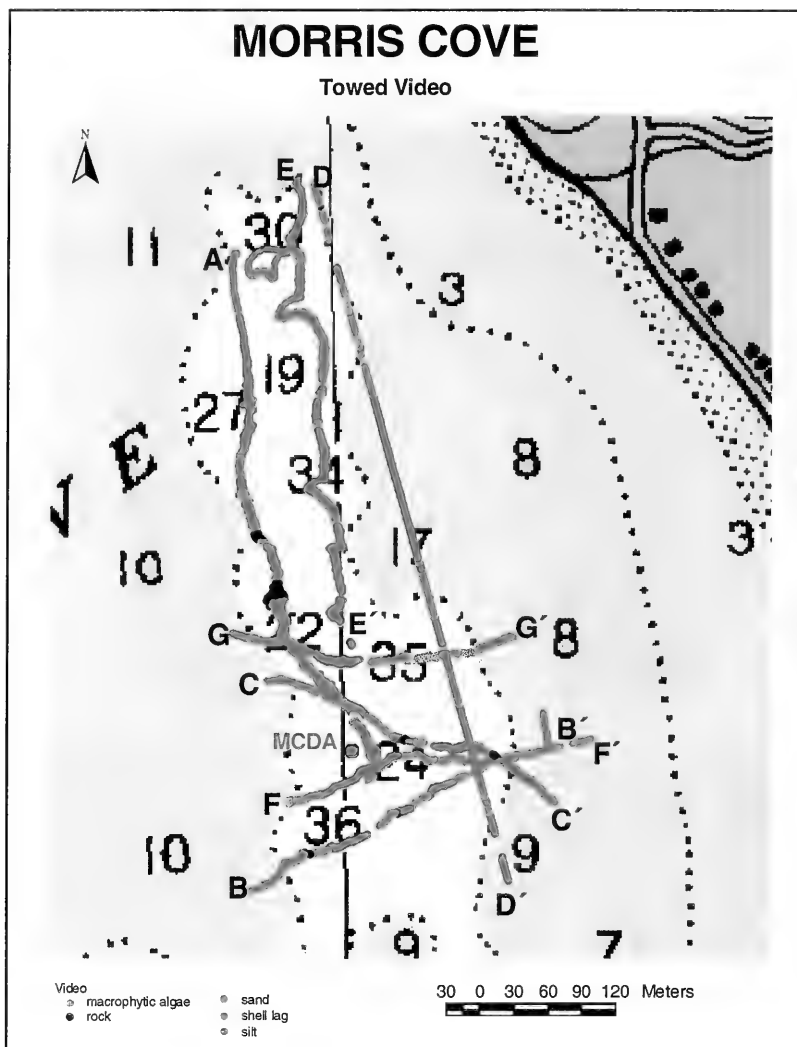
**Figure 3-15.** Aerial perspective of towed video Transects A through G showing agreement in sediment classification between overlapping and closely spaced tracklines.

Two additional transects (one longitudinal and one transverse) were occupied and results overlaid on the data from Transects A, B, C, D, and F (Figure 3-15). In general, strong agreement was observed in the classification of sediment along the margins and within the northern portion of the borrow pit. The surface sediment distribution within the southern portion of the borrow pit appeared more heterogeneous as differences in sediment classification were noted on several overlapping, or closely spaced tracklines (i.e. Transects A and F). This disagreement is likely the result of the chaotic nature of the dredged material and the many small patches of fine sand, silt, and shell on the surface of the deposit.
